**Flood Control Project Maintenance
Levee Inspections**
LMA District Cover Sheet
Spring 2017 Levee Inspection Results

Levee District No. 0001 (Glenn County)

Spring 2017 Levee Inspection Results

Waterway			Bank	Unit Miles
Unit No. 01 Sacramento River			Right	12.23
	Spring (March - May)	Summer (June - August)	(September - November) Fall	Winter (December - February)
Unit Maintenance Rating (Fall Only)				
Date of Inspection	3/28/2017 - 3/28/2017			
DWR Inspector	Bob Duffey			
Accompanied By	Bill Carriere LD1G

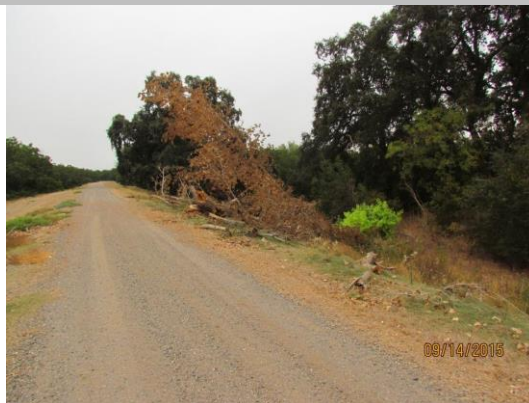
Photo 1 of 2 : SP_2017_LD0001G_432_41_20170315_00010.jpg

View of the tree on the waterside slope.

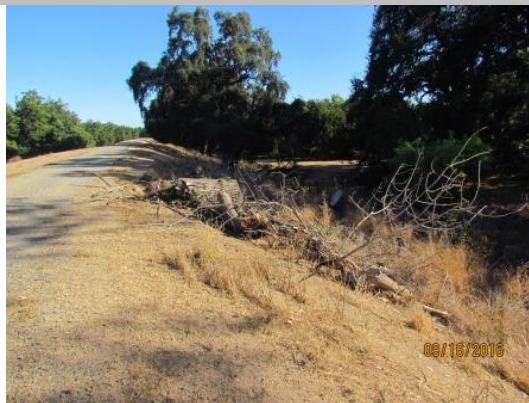
Photo 2 of 2 : SP_2017_LD0001G_432_41_20170315_00011.jpg

View of the fallen tree on the waterside slope looking upstream.

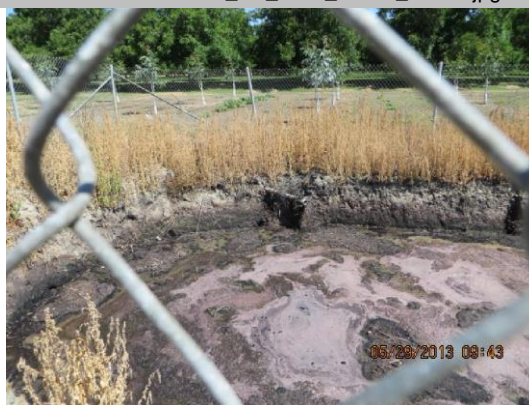
Photo 1 of 3 : UCIP_SP_2017_14324_23564.jpg

LM Start	0.77	Rating **	M	Issue No.	396
LM End	0.77	Issue Type +	En	Location *	WS
Category	Supplemental			GPS Latitude/Longitude	
				Start	End
Item	DWR UCIP Field Study			39.487806 °	39.487806 °
				-122.019414 °	-122.019414 °
DWR ID					
Comment Code					
Inspector Comment					
FS_ID:14324 DS_ID:22893 EP_NO: 11782 Repair Type: Non-Urgent Crossing Status: Found UCIP Comments: 5/29/2013 - Siphon breaker missing from WS shoulder (W. Wylie - DWR UCIP) FIELD_STRUCT_DESC: 3-inch galvanized steel pipe through levee, 2 feet below the crown. There is a hose bib style siphon breaker on the waterside (WS) shoulder. A pipe runs from the concrete sump next to the barn on the landside (LS) to a cesspool off of the WS toe (Permit No. 11782, 1977 - Carriere Brothers). [Additional Reference(s): DWR Levee Logs, 1992] FS Date: 5/29/2013

3-inch pipe at cesspool off WS toe.

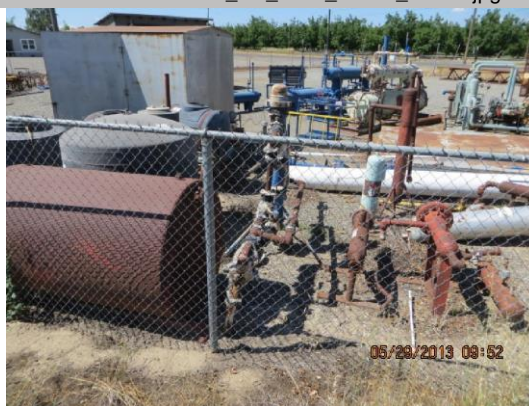
Photo 1 of 3 : UCIP_SP_2017_14325_23568.jpg

LM Start	0.80	Rating **	M	Issue No.	397
LM End	0.80	Issue Type +	En	Location *	WS
Category	Supplemental			GPS Latitude/Longitude	
				Start	End
Item	DWR UCIP Field Study			39.488160 °	39.488160 °
				-122.019888 °	-122.019888 °
DWR ID					
Comment Code					
Inspector Comment					
FS_ID:14325					
DS_ID:22894					
EP_NO: 1837					
Repair Type: Non-Urgent					
Crossing Status: Indicator Found					
UCIP Comments: 5/29/2013 - Gasline appears abandoned, need to verify abandonment or mark actual pipe location. (W. Wylie - DWR UCIP)					
FIELD_STRUCT_DESC: 3-inch gas line of an unknown material through the levee, 2 feet below the crown (Permit No. 1837, 1959 - Sunray Oil Corporation). Fenced in pumping plant area next to levee with appurtenances. [Additional Reference(s): DWR Levee Logs, 1992].					
FS Date: 5/29/2013

Gas pumping plant and appurtenances.

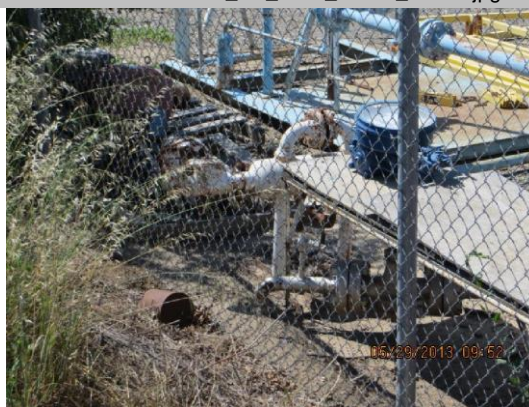
Photo 2 of 3 : UCIP_SP_2017_14325_23567.jpg

Possible pipe at crossing, LS toe.

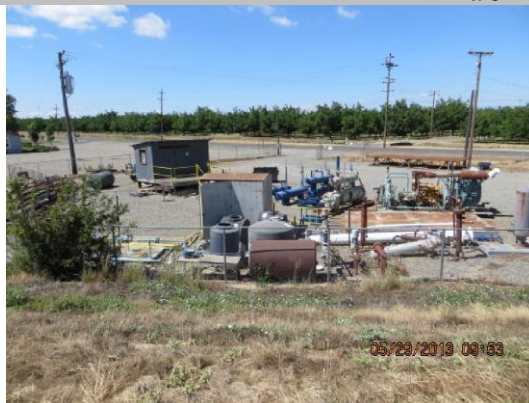
Photo 3 of 3 : UCIP_SP_2017_14325_23566.jpg

Gas pumping plant and appurtenances.

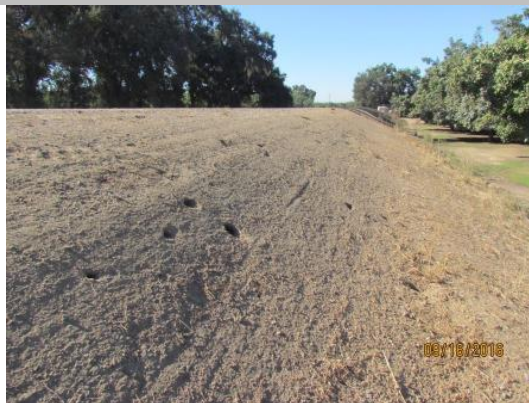
Photo 2 of 2 : SP_2017_LD0001G_432_59_20170315_00026.jpg

View of the rodent holes along the landside slope.

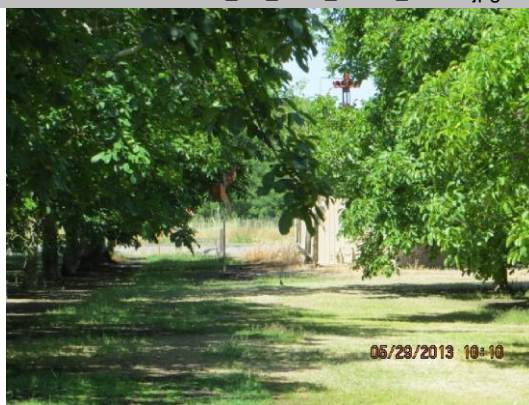
Photo 1 of 1 : UCIP_SP_2017_14327_23569.jpg

LM Start	1.25	Rating **	M	Issue No.	399
LM End	1.25	Issue Type +	En	Location *	LS
Category	Supplemental			GPS Latitude/Longitude	
				Start	End
Item	DWR UCIP Field Study			39.493977 °	39.493977 °
				-122.018380 °	-122.018380 °
DWR ID					
Comment Code					
Inspector Comment					
FS_ID:14327					
DS_ID:22896					
EP_NO: 2171					
Repair Type: Non-Urgent					
Crossing Status: Indicator Found					
UCIP Comments: Appears abandoned as well off LS toe has been removed. Need to remove from levee or mark as appropriate.					
FIELD_STRUCT_DESC: 2 of 2: 3-inch gas pipe of unknown material through the levee, 2 feet below the crown. Abandoned gas-pump station 260-feet off LS toe. (Permit No. 2171, 1958 - Sunray Mid-Continent Oil Company). [Additional Reference(s): DWR Levee Log, 1992]					
FS Date: 5/29/2013

Gasline markers near where removed pumping plant was located.

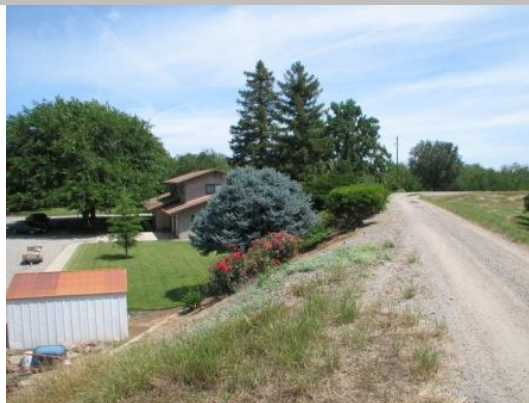
Photo 1 of 1 : SP_2017_LD0001G_432_6_20170315_00002.jpg

View of the permitted landscape on the landside slope of the levee.

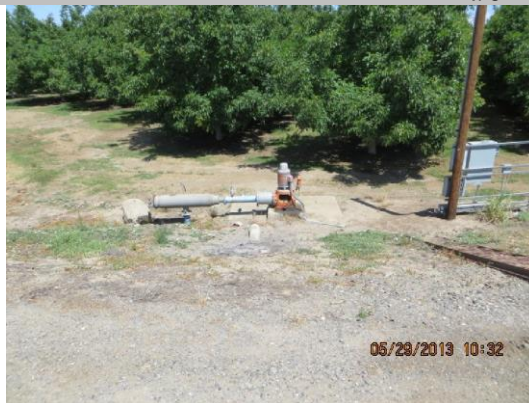
Photo 1 of 2 : UCIP_SP_2017_14331_23579.jpg

LM Start	2.22	Rating **	M	Issue No.	401
LM End	2.22	Issue Type +	En	Location *	LS
Category	Supplemental			GPS Latitude/Longitude	
				Start	End
Item	DWR UCIP Field Study			39.501690 °	39.501690 °
				-122.006100 °	-122.006100 °
DWR ID					
Comment Code					
Inspector Comment					
FS_ID:14331					
DS_ID:22898					
EP_NO: 5717A					
Repair Type: Non-Urgent					
Crossing Status: Found					
UCIP Comments: Pipe abandoned and should be done so properly.					
FIELD_STRUCT_DESC: 8-inch asbestos cement irrigation pipe sleeved through 12-inch though the levee, 5 feet below the crown. Pump is located on the landside (LS). Meter pole located on the LS toe, guy wire anchor in LS slope. (Permit No. 5717A, 1969 - W. A. Carriere).					
[Additional Reference(s): DWR Levee Log, 1992]					
FS Date: 5/29/2013

Pump at LS toe with no connection to 8-inch pipe.

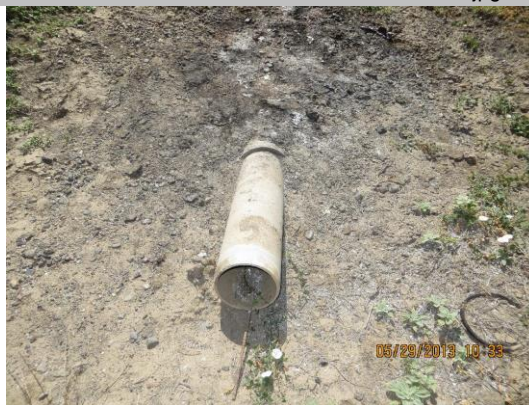
Photo 2 of 2 : UCIP_SP_2017_14331_23578.jpg

8-inch pipe visible at LS toe.

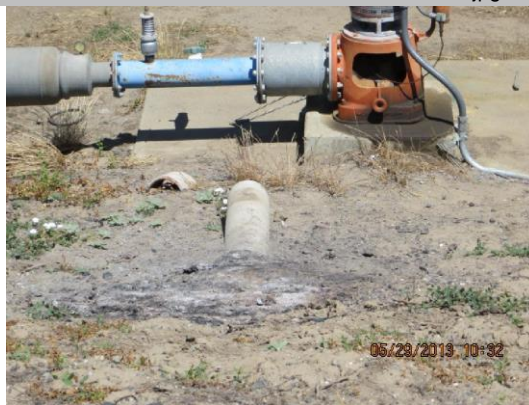
Photo 2 of 3 : UCIP_SP_2017_14332_23581.jpg

FS_ID:14332
DS_ID:22944
EP_NO: N/A
Repair Type: Non-Urgent
Crossing Status: Found
UCIP Comments: Appears abandoned and should be done so properly.
FIELD_STRUCT_DESC: *ABANDONED* 8-inch pipe of unknown material sleeved through a 12-inch pipe of unknown material through levee, 9.5 feet below crown. Flap gate is located on the waterside (WS). Pipe is opened on the landside (LS). [Additional Reference(s): USACE Sacramento O&M Manual Unit 140, May 1960, (HLM 2.27)].
FS Date: 5/29/2013

Pipe next to pump at LS toe.

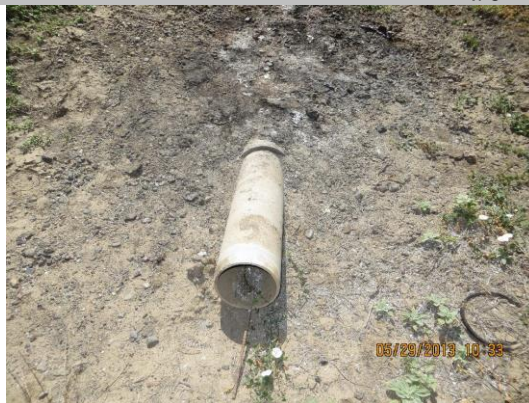
Photo 3 of 3 : UCIP_SP_2017_14332_23580.jpg

LM Start	2.22	Rating **	M	Issue No.	402 (cont)	
LM End	2.22	Issue Type +	Ma	Location *	LS	
Category	Supplemental			GPS Latitude/Longitude		
				Start	End	
Item	DWR UCIP LMA Responsibility			39.501690 °	39.501690 °	
				-122.006099 °	-122.006099 °	
DWR ID						
Comment Code						
Inspector Comment						
FS_ID:14332						
DS_ID:22944						
EP_NO: N/A						
Repair Type: Non-Urgent						
Crossing Status: Found						
UCIP Comments: Appears abandoned and should be done so properly.						
FIELD_STRUCT_DESC: *ABANDONED* 8-inch pipe of unknown						
material sleeved through a 12-inch pipe of unknown material through						
levee, 9.5 feet below crown. Flap gate is located on the waterside						
(WS). Pipe is opened on the landside (LS). [Additional Reference(s):						
USACE Sacramento O&M Manual Unit 140, May 1960, (HLM 2.27)].						
FS Date: 5/29/2013

8-inch pipe sleeved through a 12-inch concrete pipe.

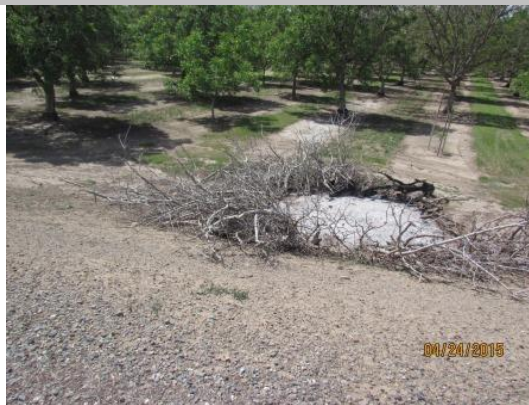
Photo 1 of 2 : SP_2017_LD0001G_432_61_20170315_00027.jpg

LM Start	2.48	Rating **	M	Issue No.	61
LM End	2.48	Issue Type +	En	Location *	LS
Category	Earthen Levee			GPS Latitude/Longitude	
				Start	End
Item	Encroachments			39.505237 °	39.505237 °
				-122.006493 °	-122.006493 °
DWR ID	DWR_LD0001G_01_s_2015_61				
Comment Code					
PR : Prunings					
Inspector Comment					
Remove prunings from the LS toe.

View of the prunings along the landside toe.

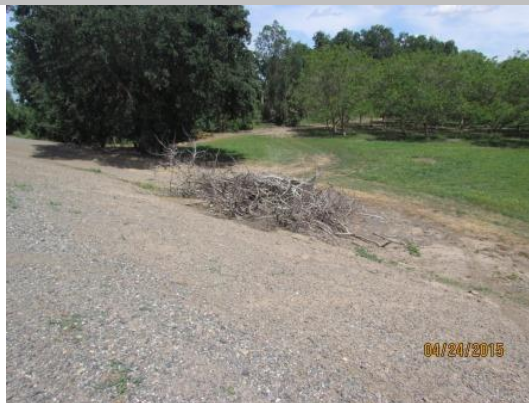
Photo 1 of 1 : SP_2017_LD0001G_432_62_20170315_00029.jpg

View of the pruning on the waterside toe.

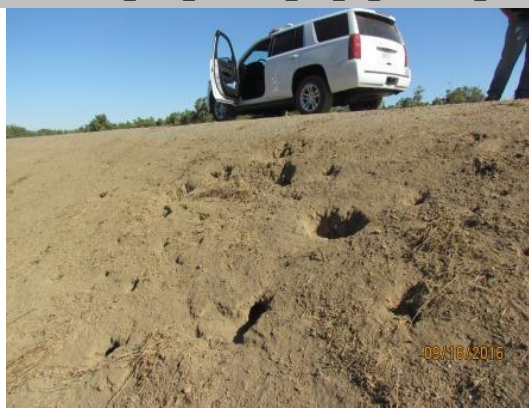
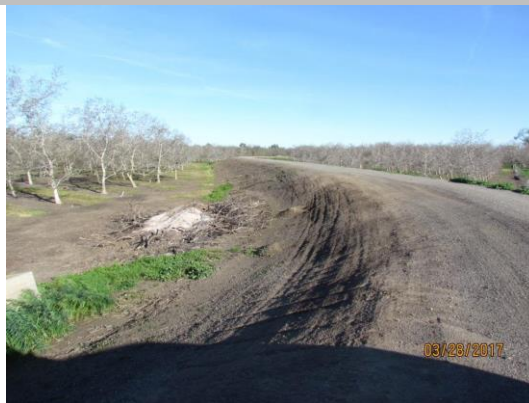
LM Start	3.04	Rating **	U	Issue No.	51
LM End	3.13	Issue Type +	Ma	Location *	LS
Category	Earthen Levee			GPS Latitude/Longitude	
				Start	End
Item	Animal Control			39.512818 °	39.513870 °
				-122.009027 °	-122.010078 °
DWR ID	DWR_LD0001G_01_f_2014_51				
Comment Code					
A3 : No rodents visible, but rodent burrows visible; need to backfill and compact or grout burrows.					
Inspector Comment					
Repair the levee slope damaged by rodent activity.

View of the rodent holes along the landside slope.

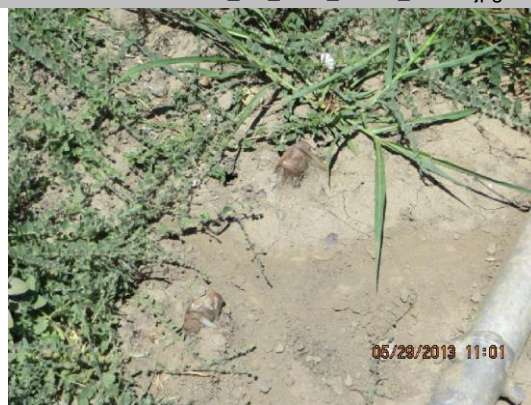
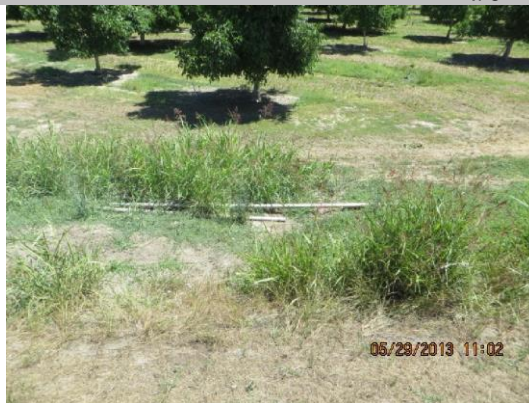
LM Start	3.13	Rating **	M	Issue No.	403
LM End	3.13	Issue Type +	En	Location *	LS
Category	Supplemental			GPS Latitude/Longitude	
				Start	End
Item	DWR UCIP Field Study			39.513835 °	39.513835 °
				-122.010029 °	-122.010029 °
DWR ID					
Comment Code					
Inspector Comment					
FS_ID:16223 DS_ID:22901 EP_NO: 9575 Repair Type: Non-Urgent Crossing Status: Found UCIP Comments: Appears to have been abandoned. Need to verify pipe was grouted/abandoned properly. FIELD_STRUCT_DESC: *ABANDONED* 12-inch pipe through levee 14.0 feet below crown. Flap Gate on waterward end (ABO No. 9575, 1974). [Additional Reference(s): DWR Levee Log, 1992]. FS Date: 5/29/2013

Flap gate visible at WS toe.

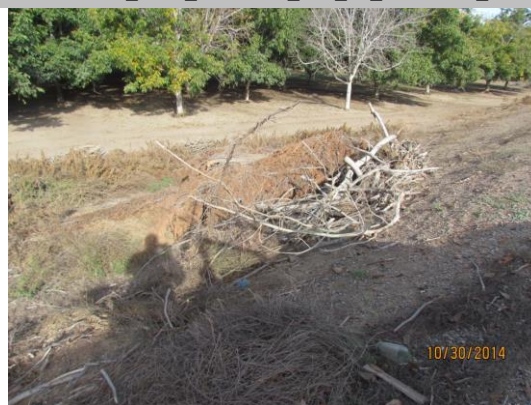
Photo 1 of 1 : SP_2017_LD0001G_432_52_20170315_00020.jpg

View of the prunings along the landside toe.

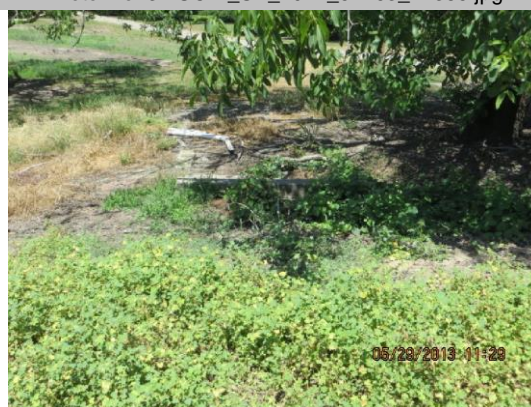
Photo 2 of 3 : UCIP_SP_2017_51463_27385.jpg

Comment Code					
Inspector Comment					
FS_ID:51463 DS_ID:22904 EP_NO: 9572 Repair Type: Urgent Crossing Status: Found UCIP Comments: 12/21/2016 Flap gate on WS does not appear to be broken however, flap gate does not fully close due to a 3-inch aluminum pipe sleeve through larger pipe. Need to remove 3-inch pipe in order to have WS flap gate close and to be compliant with Title 23. (O. Magana - DWR UCIP)05/29/2013 Broken flap gate and Concrete headwall on LS toe possibly tilting. Also a 3-inch alluminum irrigation line through the pipe. (W. Wylie - DWR UCIP) FIELD_STRUCT_DESC: 18-inch steel drainage pipe through levee, 7.3 feet below crown. Flap gate in 6-inch by 6-inch concrete box located on the waterside (WS) end. Concrete headwall located on the landside (LS) toe. (18-inch pipe authorized under Automatic Board Order (ABO) issued as Permit No. 9572, 1974 - H. & A. Smith). [Additional Reference(s): DWR Levee Log, 1992. USACE Sacramento O&M Manual Unit 140, May 1960, (HLM 4.05)]. FS Date: 12/21/2016

Headwall on LS toe.

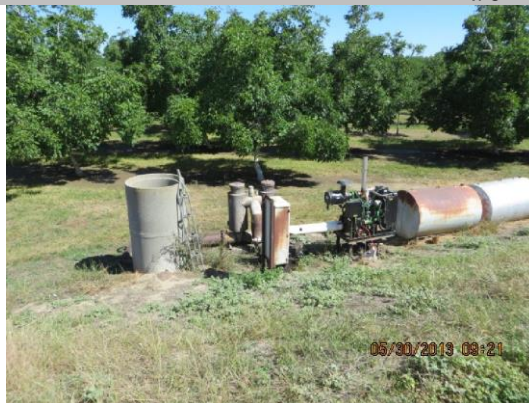
Photo 1 of 3 : UCIP_SP_2017_51284_23594.jpg

Comment Code					
Inspector Comment					
FS_ID:51284 DS_ID:22906 EP_NO: 1229 Repair Type: Non-Urgent Crossing Status: Found UCIP Comments: 12/21/2016 same as last inspection. Crossing has been modified from original permit. Need to contact owner to determine permit number issued for modification and to determine current status of crossing. Crossing has been downgraded from Urgent to Non-Urgent due to no damage observed on levee slopes or crown. (O. Magana - DWR UCIP)05/30/2013 Gate valve broken off in concrete standpipe on WS shoulder. 8-inch aluminum pipe sleeved through pipe prevents closure of 18-inch pipe. All concrete standpipes have been modified or broken. (W. Wylie - DWR UCIP) FIELD_STRUCT_DESC: 16-inch concrete (not 18-inch asphalt dipped steel as referenced in permit or USACE O&M manual) irrigation pipe through the levee, 8.6 feet below the crown. Gate valve in concrete well located on the waterside (WS) slope. Pump, service pole, engine, and fuel tank 48-inch, and standpipe are located on the toe of the landside (LS) slope (Permit No. 1229, 1947 - R. T. Miller). [Additional Reference(s): DWR Levee Log, 1992. USACE Sacramento O&M Manual Unit 140, May 1960, (HLM 4.33)]. FS Date: 12/21/2016

Pump, standpipe, and gate valve on LS toe.

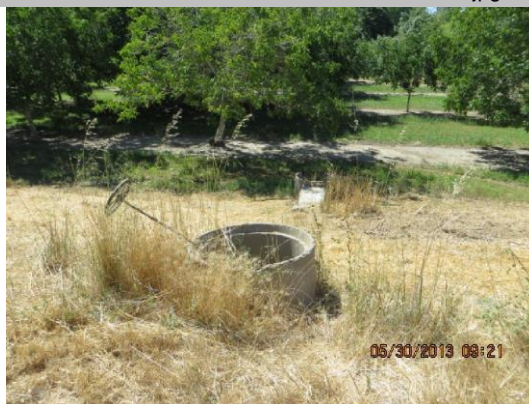
Photo 2 of 3 : UCIP_SP_2017_51284_23593.jpg

Gate valve in Concrete riser on WSs houlder.

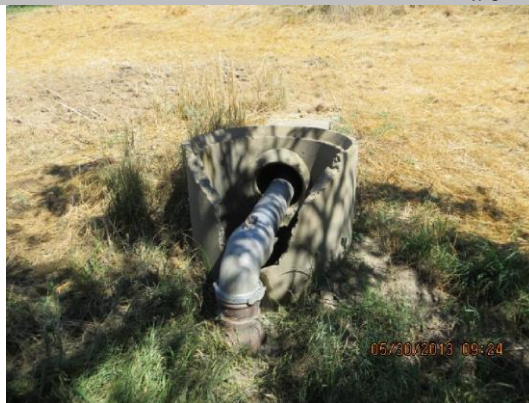
Photo 3 of 3 : UCIP_SP_2017_51284_23592.jpg

Item	DWR UCIP Field Study			39.527050 °		39.527050 °
				-122.005247 °		-122.005247 °
DWR ID						
Comment Code						
Inspector Comment						
FS_ID:51284 DS_ID:22906 EP_NO: 1229 Repair Type: Non-Urgent Crossing Status: Found UCIP Comments: 12/21/2016 same as last inspection. Crossing has been modified from original permit. Need to contact owner to determine permit number issued for modification and to determine current status of crossing. Crossing has been downgraded from Urgent to Non-Urgent due to no damage observed on levee slopes or crown. (O. Magana - DWR UCIP)05/30/2013 Gate valve broken off in concrete standpipe on WS shoulder. 8-inch aluminum pipe sleeved through pipe prevents closure of 18-inch pipe. All concrete standpipes have been modified or broken. (W. Wylie - DWR UCIP) FIELD_STRUCT_DESC: 16-inch concrete (not 18-inch asphalt dipped steel as referenced in permit or USACE O&M manual) irrigation pipe through the levee, 8.6 feet below the crown. Gate valve in concrete well located on the waterside (WS) slope. Pump, service pole, engine, and fuel tank 48-inch, and standpipe are located on the toe of the landside (LS) slope (Permit No. 1229, 1947 - R. T. Miller). [Additional Reference(s): DWR Levee Log, 1992. USACE Sacramento O&M Manual Unit 140, May 1960, (HLM 4.33)]. FS Date: 12/21/2016

8-inch pipe sleeved through 16-inch pipe at LS toe.

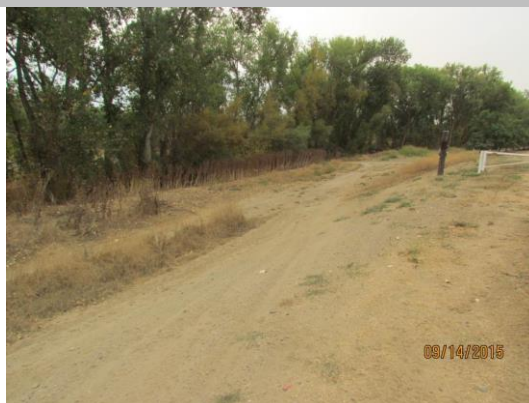
Photo 1 of 1 : SP_2017_LD0001G_432_63_20170315_00030.jpg

LM Start	4.93	Rating **	M	Issue No.	63
LM End	4.93	Issue Type +	Ma	Location *	WS
Category	Earthen Levee			GPS Latitude/Longitude	
				Start	End
Item	Slope Stability			39.532719 °	39.532719 °
				-121.995849 °	-121.995849 °
DWR ID	DWR_LD0001G_01_f_2015_63				
Comment Code					
S3 : Repair the levee slope damaged by vehicle traffic and prevent access where possible.					
Inspector Comment					
Repair the erosion along the WS slope.

View of the vehicle erosion along the waterside slope.

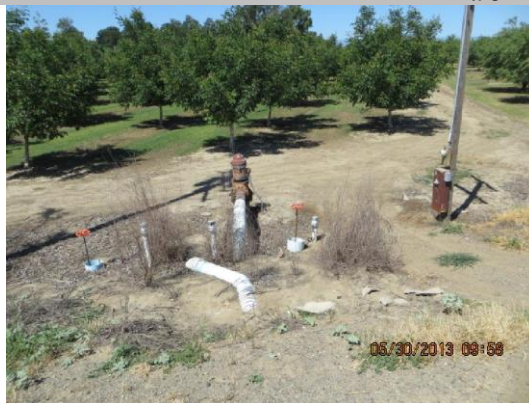
Photo 1 of 3 : UCIP_SP_2017_14346_23601.jpg

LM Start	5.51	Rating **	A/W	Issue No.	406
LM End	5.51	Issue Type +	Ma	Location *	LS
Category	Supplemental			GPS Latitude/Longitude	
				Start	End
Item	DWR UCIP LMA Responsibility			39.540546 °	39.540546 °
				-121.998981 °	-121.998981 °
DWR ID					
Comment Code					
Inspector Comment					
FS_ID:14346 DS_ID:22907 EP_NO: 344 Repair Type: No Action Needed Crossing Status: Found UCIP Comments: FIELD_STRUCT_DESC: 12-inch pipe through levee 6.5 feet below crown. Gate valve at toe of waterward slope. Air vent and pump at LS toe. (ABO No. 9566, 1974) (App. No. 344-Giesbrecht) Originally included in the 1960 O&M manual. [Additional Reference(s): DWR Levee Log, 1992. USACE Sacramento O&M Manual Unit 140, May 1960, (HLM 5.61)]. FS Date: 5/30/2013

Pump, vent, and pipe on LS toe.

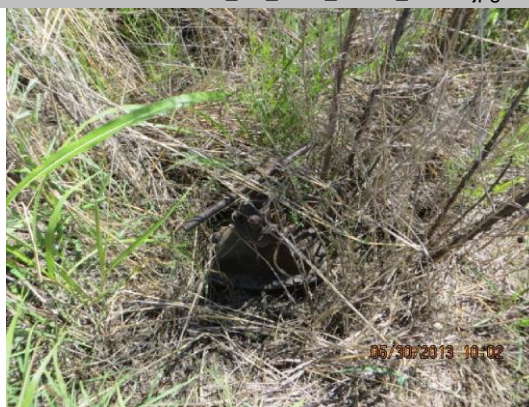
Photo 2 of 3 : UCIP_SP_2017_14346_23600.jpg

Gate valve on WS toe.

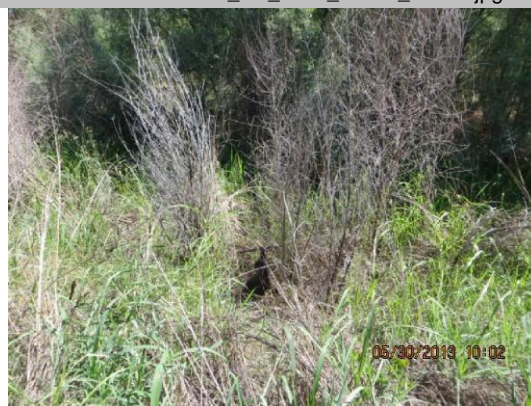
Photo 3 of 3 : UCIP_SP_2017_14346_23599.jpg

Gate valve on WS toe.

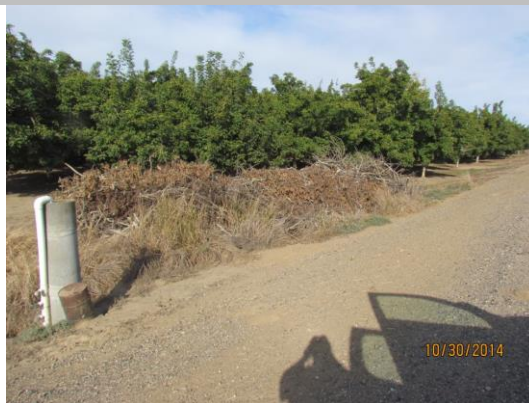
Photo 1 of 1 : SP_2017_LD0001G_432_54_20170315_00021.jpg

View of the prunings along the landside toe.

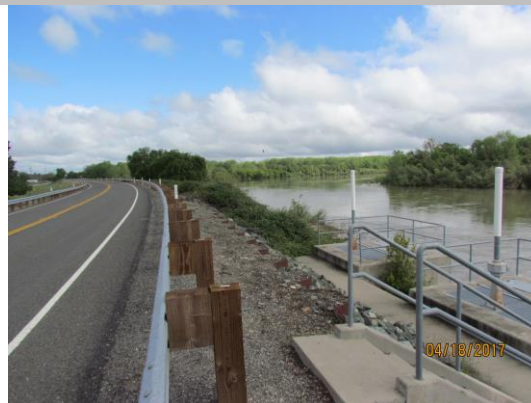
Photo 1 of 1 : SP_2017_LD0001G_432_77_20170418_00122.jpg

View of the vegetation along the waterside slope.

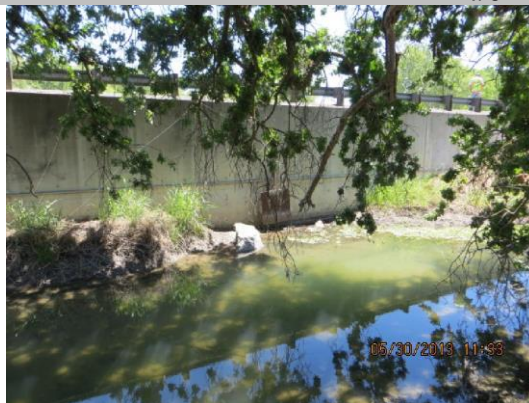
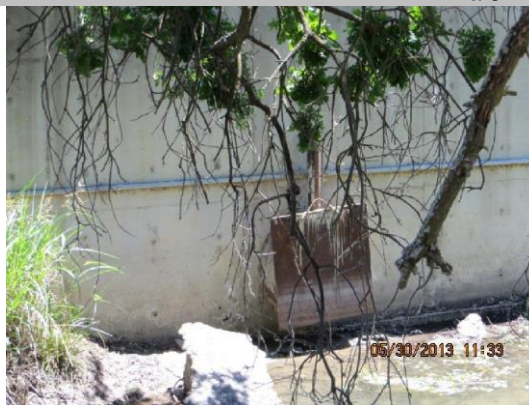
Pipe with steel plate welded over end on LS of levee crown.

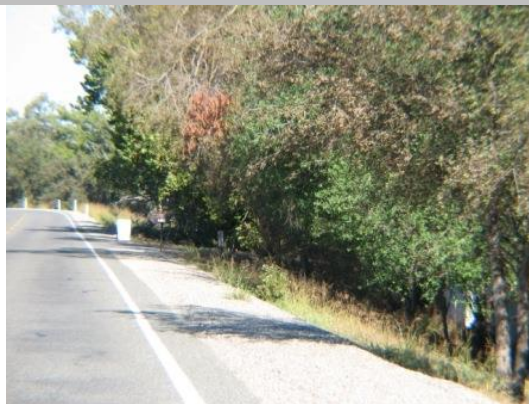
Photo 1 of 1 : SP_2017_LD0001G_432_20_20170315_00008.jpg

View of the trees and vegetation along the waterside slope of the levee.

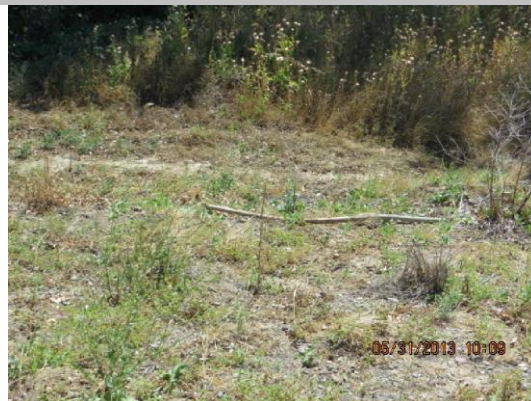
Photo 3 of 3 : UCIP_SP_2017_16204_27328.jpg

Pipe debris on WS slope may be indicator of pipe location on WS.

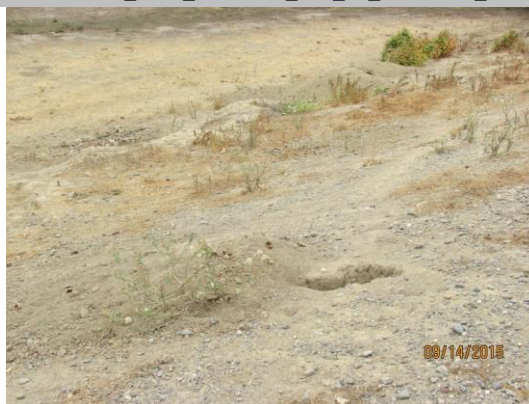
Photo 1 of 1 : SP_2017_LD0001G_432_66_20170315_00033.jpg

View of the rodent holes along the waterside slope.

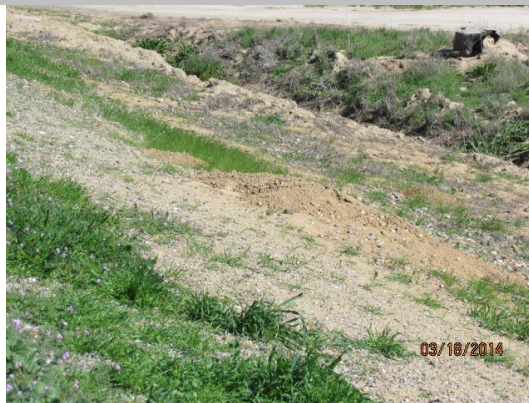
Photo 1 of 1 : SP_2017_LD0001G_432_48_20170315_00015.jpg

View of the rodent activity along the waterside slope.

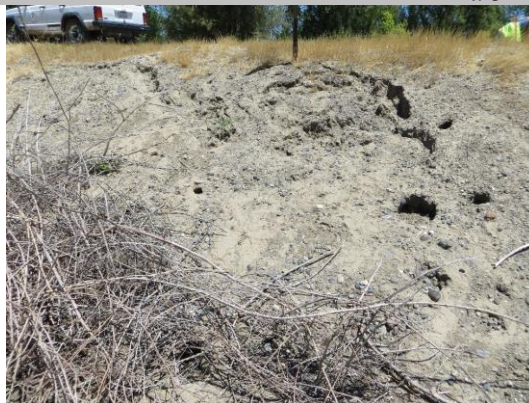
Photo 3 of 3 : UCIP_SP_2017_14567_24015.jpg

Erosion and sloughing on LS slope possibly due to rodent activity.
